CERTIFICATE OF TEST

**TEST OF TWO Y16 x 1.2 m LONG ROOF
BOLTS COMPLETE WITH NUTS, LOAD
INDICATORS AND DOMED DOG-EAR
WASHERS (Cast No.: 094505)**

Certificate No.: T15312

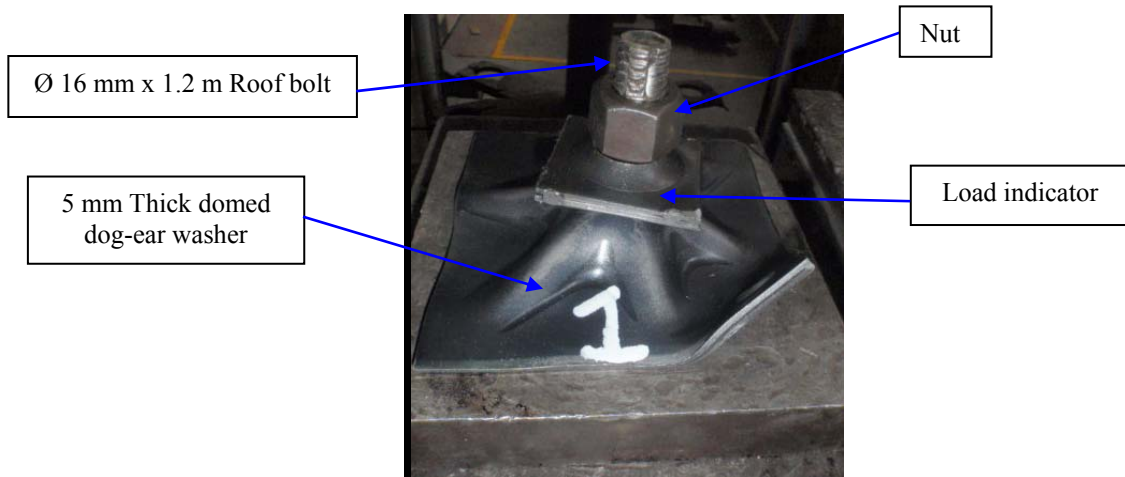
Figure 1. Y16 x 1.2 m Long Roof bolt assembly installed in the testing machine.

The nut was screwed onto the threaded end of the bar for each specimen. The load indicator together with the domed dog-ear washer were fitted adjacent to the nut. The assemblies were in turn installed in the 1000 kN Amsler Universal testing machine using suitable fittings as shown in Figure 1. A gradually increasing tensile load was applied to each assembly until failure occurred.

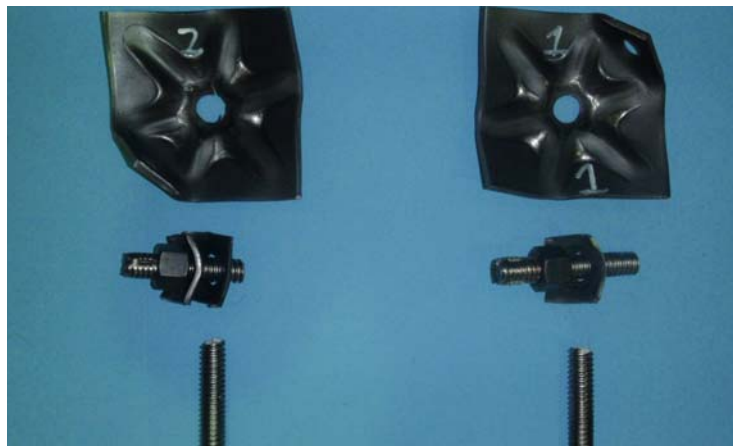
Figure 2. Y16 x 1.2 m Long Roof bolt assemblies after the test.

1. The load indicator failed (flattened).
2. The domed dog-ear washer failed (flattened).
3. The roof bolt fracture at the threaded portion as shown in Figure 2.

<u>Assembly No.</u>	Maximum load carried by the domed dog-ear washer (kN)	Maximum load carried by the roof bolt (kN)
1	149.2	171.8
2	141.6	185.2
Average	145.4	178.5

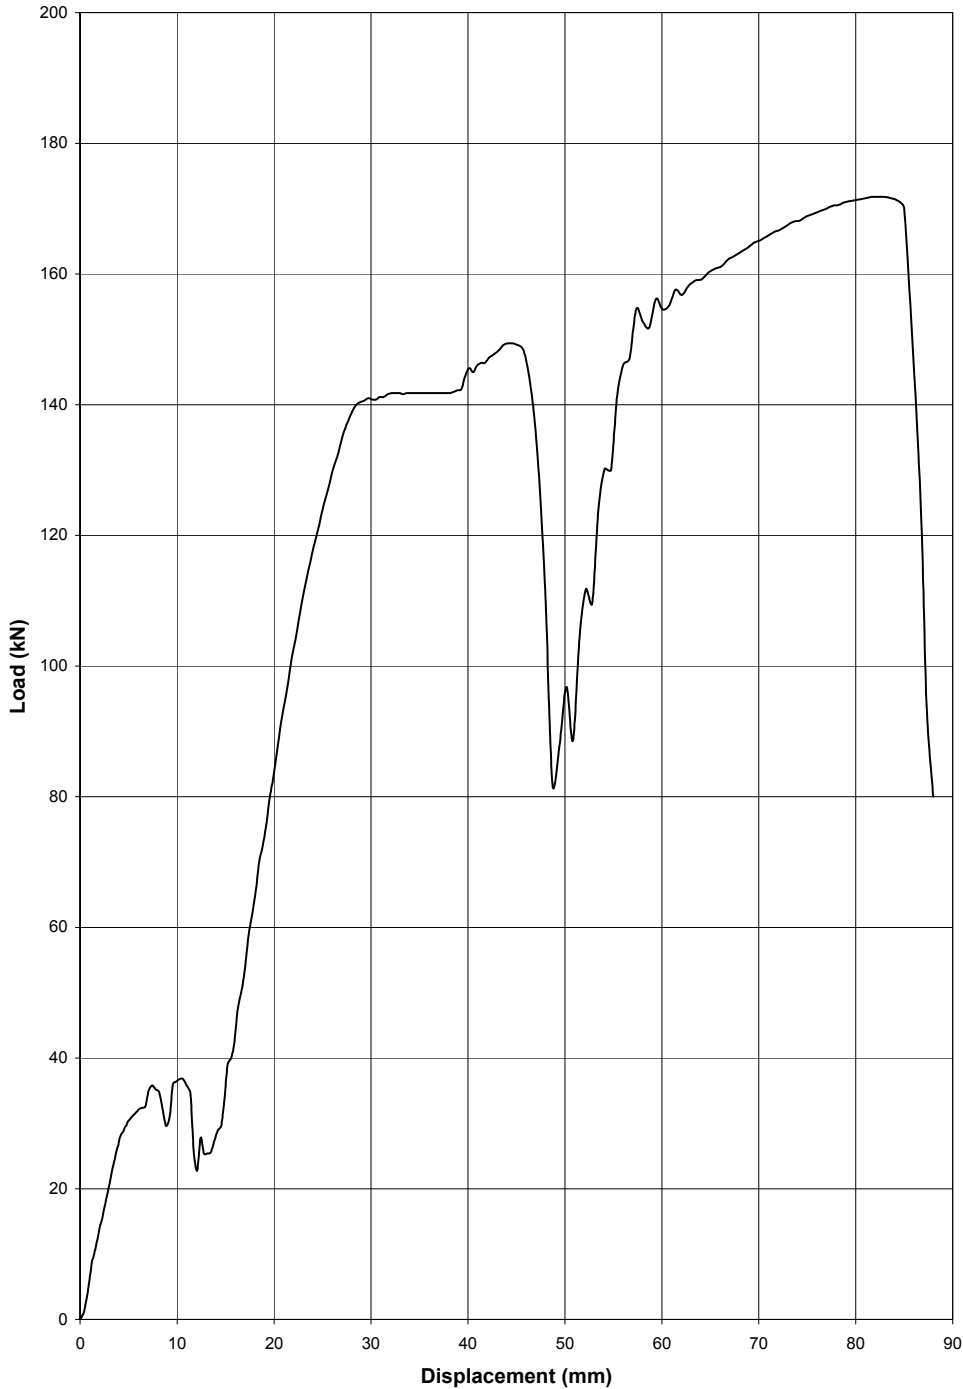
Certificate No.: T15312
Date of test: 05 May 2010
Applicant: Reunko Steel Suppliers
Description: Y16 mm x 1.2 m long roof bolt complete with nut, load indicator and 5 mm thick domed dog-ear washer (Cast No.: 094505)
Assembly No.: 1
Maximum Force: 149.2 kN (Domed dog-ear washer)
171.8 kN (Roof bolt)

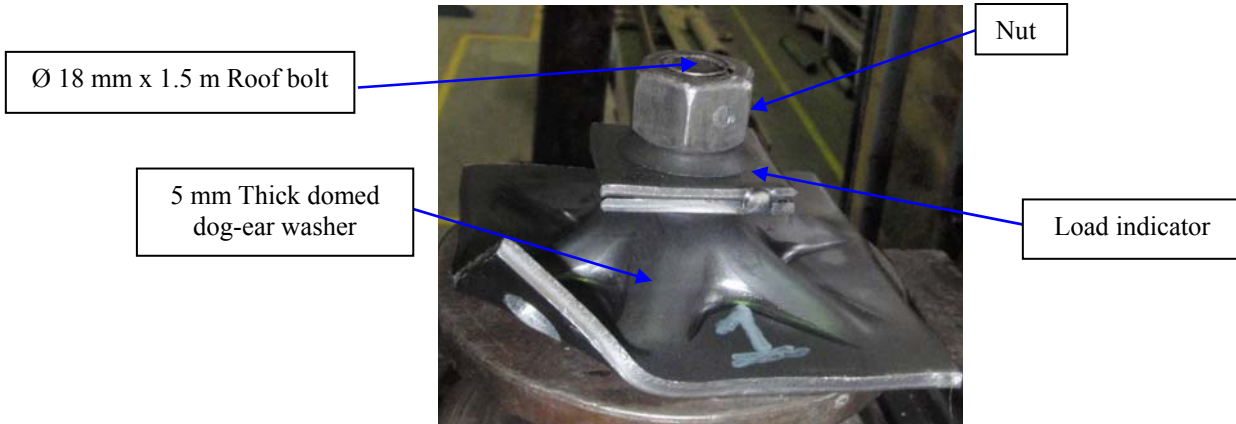
Figure 2. Y18 x 1.5 m Long Roof bolt assembly installed in the testing machine.

The nut was screwed onto the threaded end of the bar for each specimen. The load indicator together with the domed dog-ear washer were fitted adjacent to the nut. The assemblies were in turn installed in the 1000 kN Amsler Universal testing machine using suitable fittings as shown in Figure 1. A gradually increasing tensile load was applied to each assembly until failure occurred.

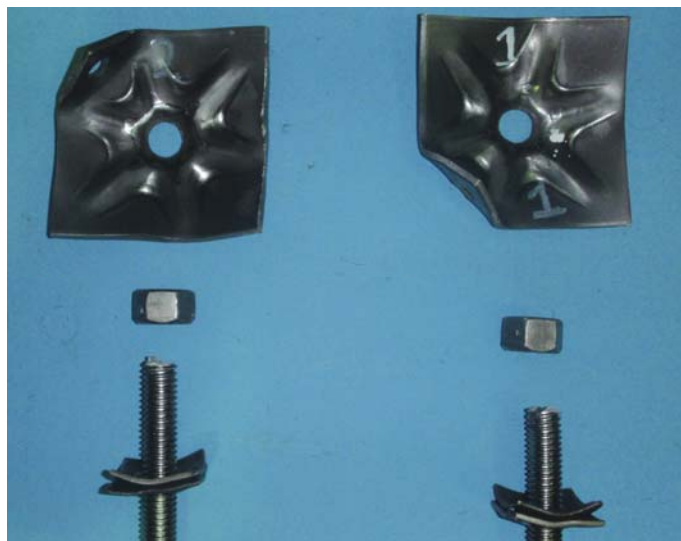
Figure 2. Y18 x 1.5 m Long Roof bolt assemblies after the test.

1. The load indicator failed (flattened).
2. The domed dog-ear washer failed (flattened).
3. The roof bolt fracture at the threaded portion as shown in Figure 2.

<u>Assembly No.</u>	Maximum load carried by the domed dog-ear washer (kN)	Maximum load carried by the roof bolt (kN)
1	156.0	208.6
2	161.8	216.3
Average	158.9	212.5

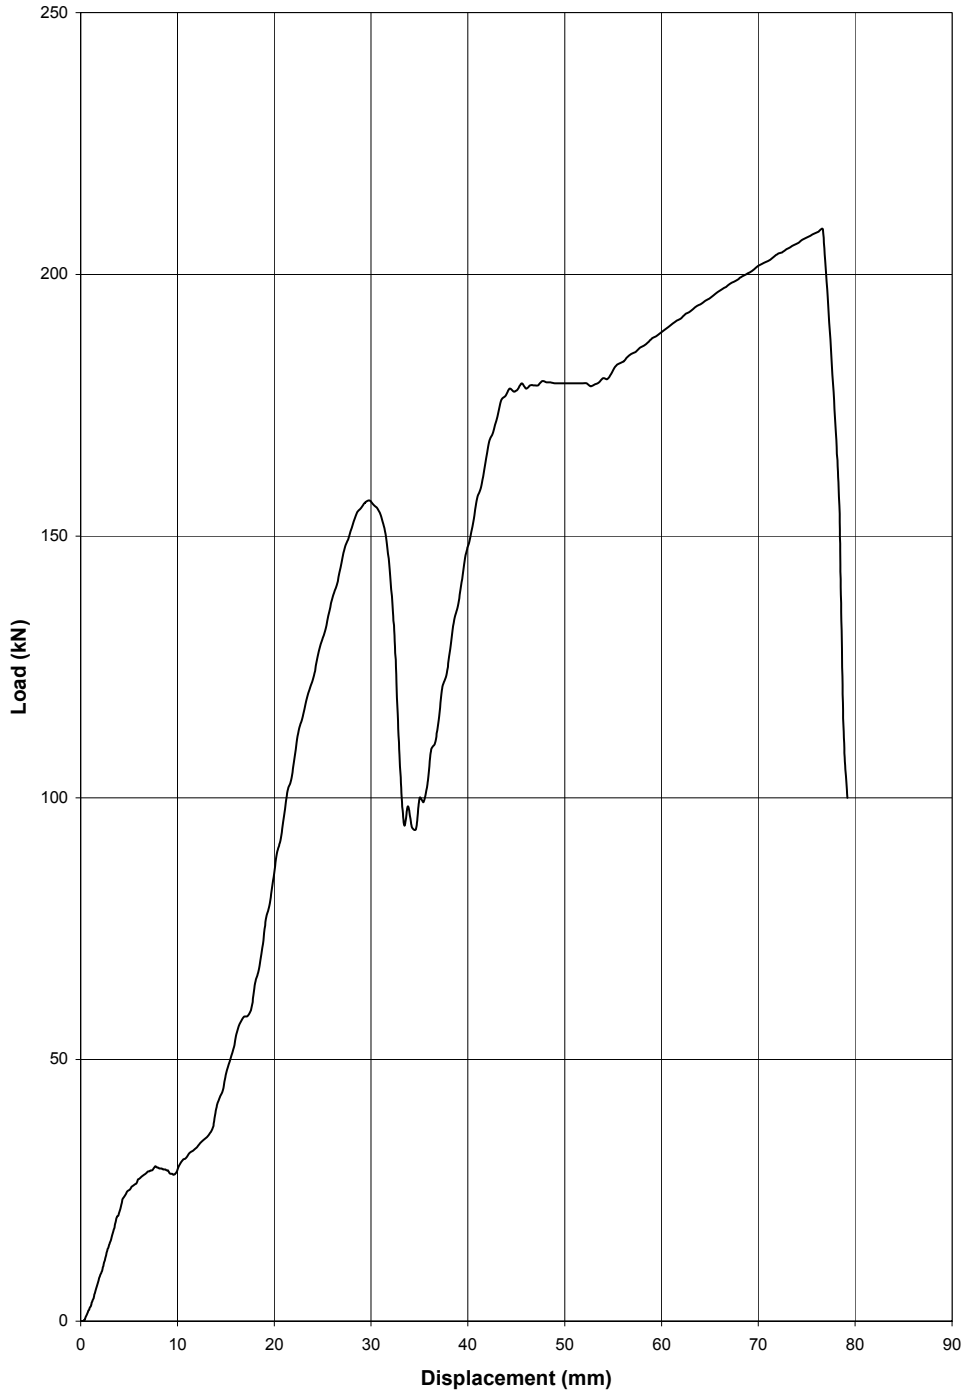
Certificate No.: T15313
Date of test: 05 May 2010
Applicant: Reunko Steel Suppliers
Description: Y18 mm x 1.5 m long roof bolt complete with nut, load indicator and 5 mm thick domed dog-ear washer (Cast No.: 093887)
Assembly No.: 1
Maximum Force: 156.0 kN (Domed dog-ear washer)
208.6 kN (Roof bolt)

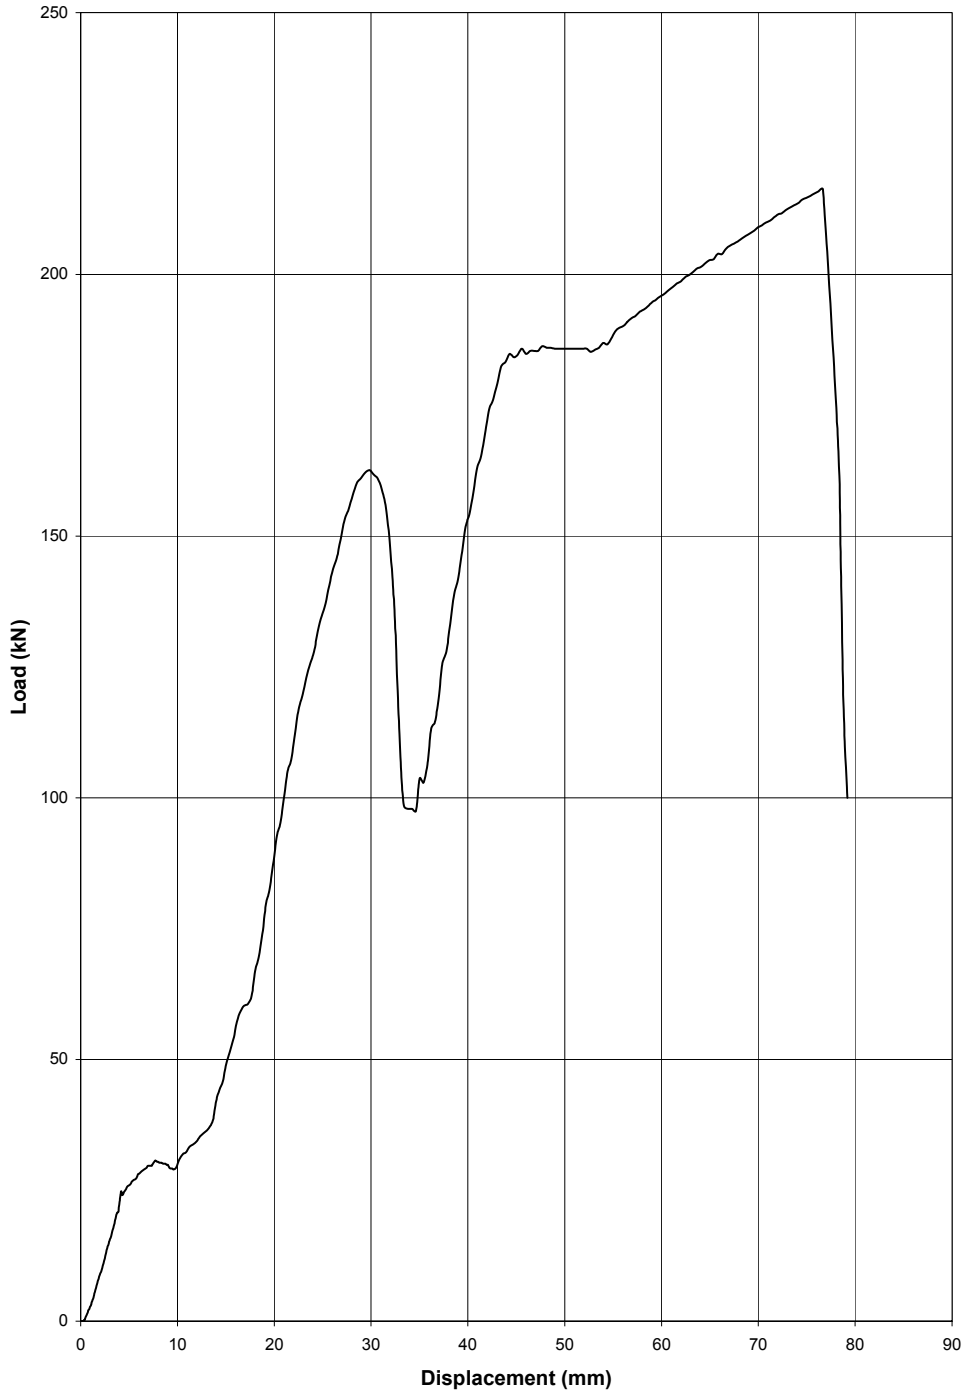
Certificate No.: T15313
Date of test: 05 May 2010
Applicant: Reunko Steel Suppliers
Description: Y18 mm x 1.5 m long roof bolt complete with nut, load indicator and 5 mm thick domed dog-ear washer (Cast No.: 093887)
Assembly No.: 2
Maximum Force: 161.8 kN (Domed dog-ear washer)
216.3 kN (Roof bolt)

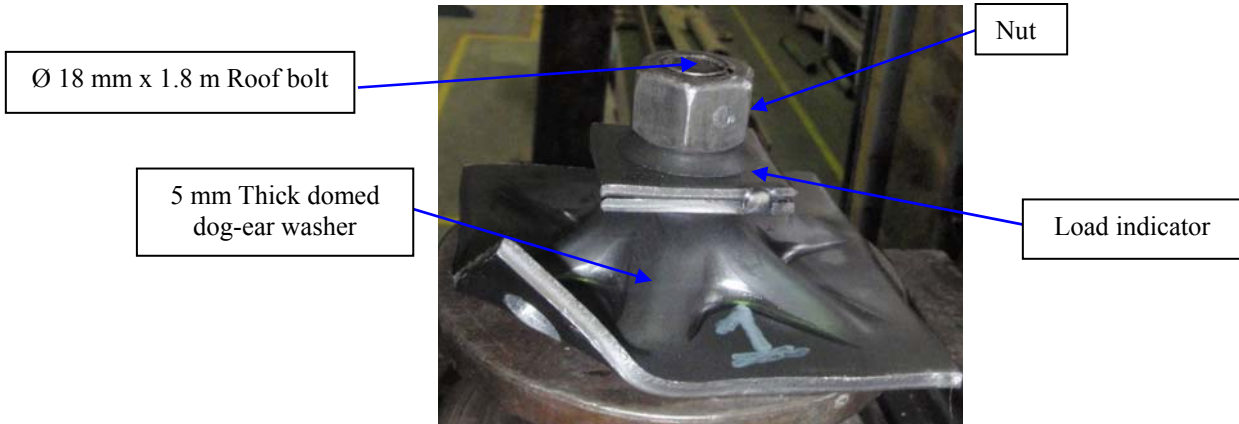
Figure 3. Y18 x 1.8 m Long Roof bolt assembly installed in the testing machine.

The nut was screwed onto the threaded end of the bar for each specimen. The load indicator together with the domed dog-ear washer were fitted adjacent to the nut. The assemblies were in turn installed in the 1000 kN Amsler Universal testing machine using suitable fittings as shown in Figure 1. A gradually increasing tensile load was applied to each assembly until failure occurred.

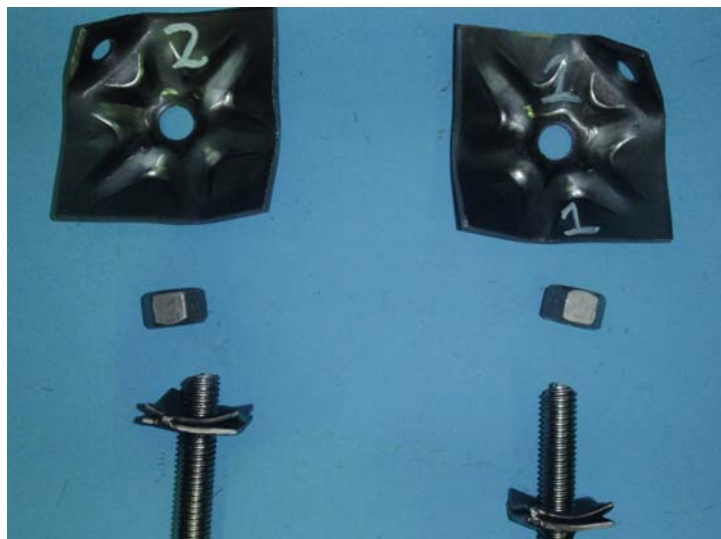
Figure 2. Y18 x 1.8 m Long Roof bolt assemblies after the test.

1. The load indicator failed (flattened).
2. The domed dog-ear washer failed (flattened).
3. The roof bolt fracture at the threaded portion as shown in Figure 2.

<u>Assembly No.</u>	Maximum load carried by the domed dog-ear washer (kN)	Maximum load carried by the roof bolt (kN)
1	154.2	207.2
2	145.6	165.2
Average	149.9	186.2

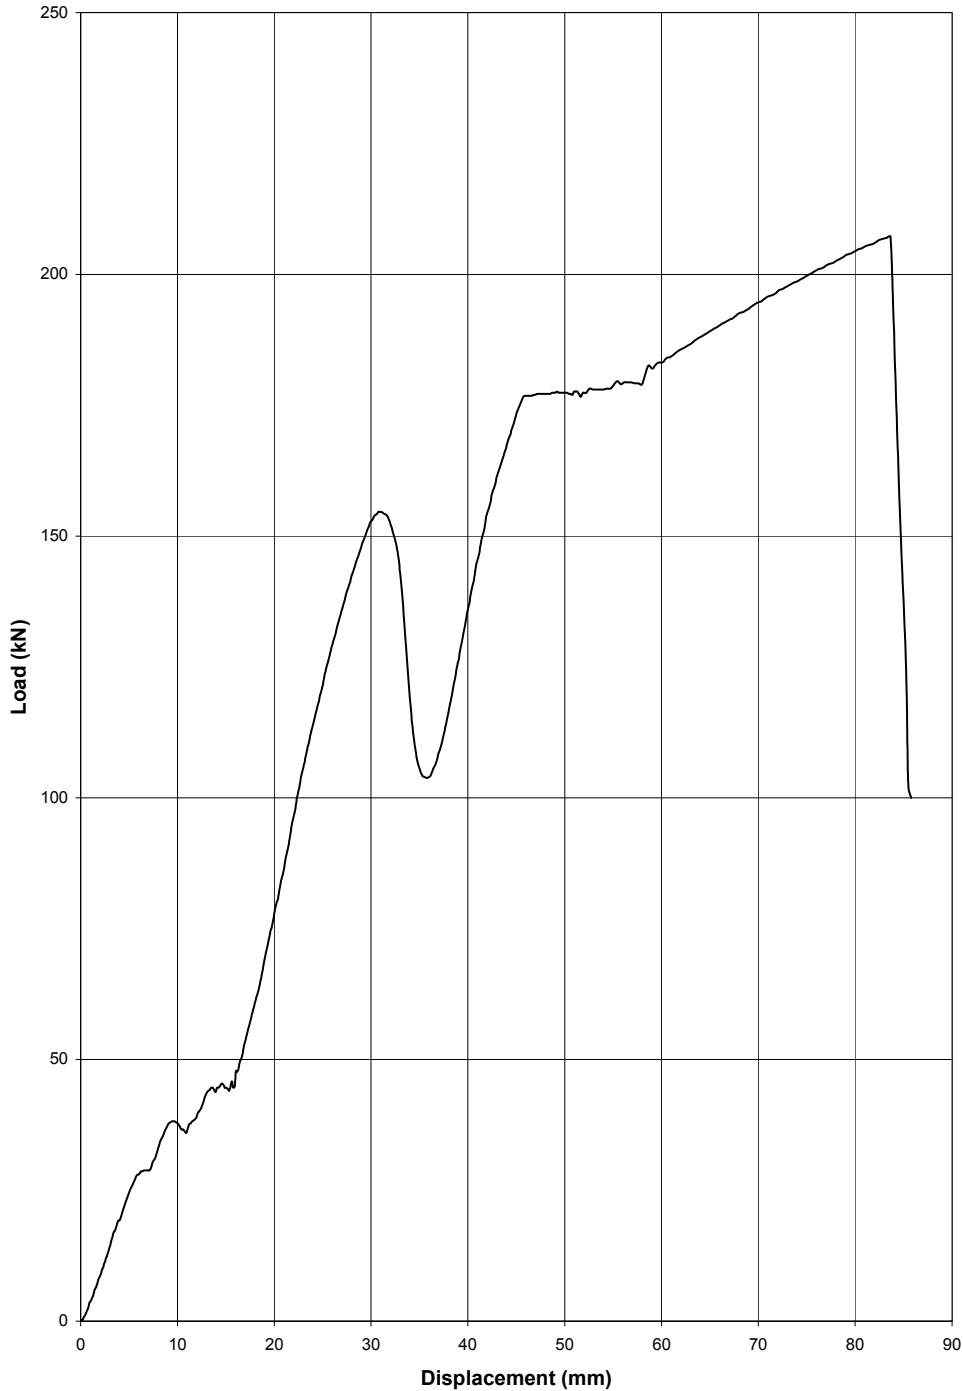
Certificate No.: T15314
Date of test: 05 May 2010
Applicant: Reunko Steel Suppliers
Description: Y18 mm x 1.8 m long roof bolt complete with nut, load indicator and 5 mm thick domed dog-ear washer (Cast No.: 093887)
Assembly No.: 1
Maximum Force: 154.2 kN (Domed dog-ear washer)
207.2 kN (Roof bolt)

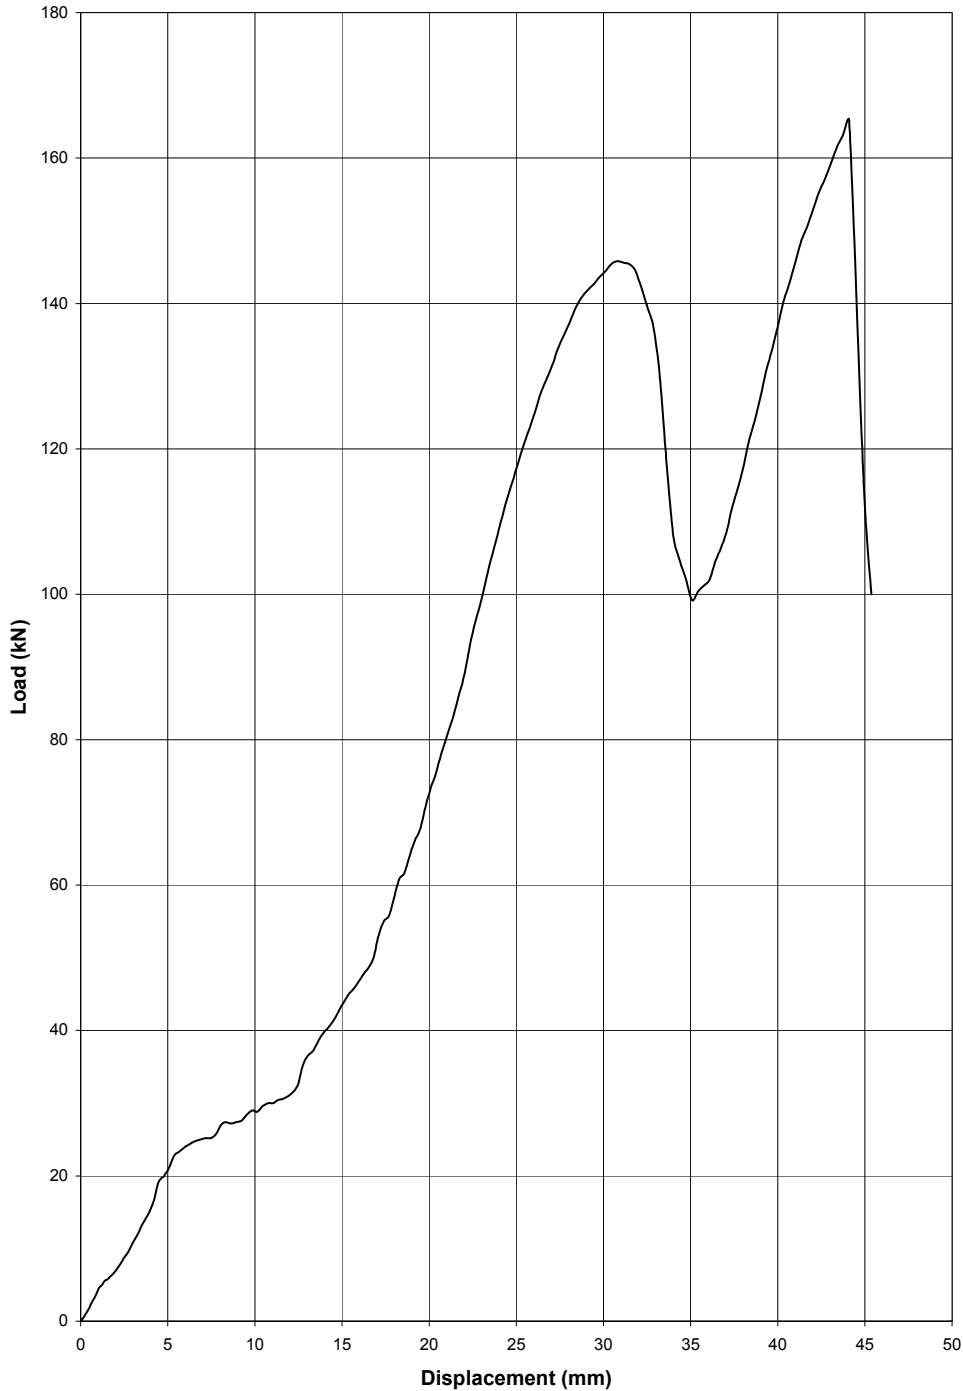
Certificate No.: T15314
Date of test: 05 May 2010
Applicant: Reunko Steel Suppliers
Description: Y18 mm x 1.8 m long roof bolt complete with nut, load indicator and 5 mm thick domed dog-ear washer (Cast No.: 093887)
Assembly No.: 2
Maximum Force: 145.6 kN (Domed dog-ear washer)
165.2 kN (Roof bolt)

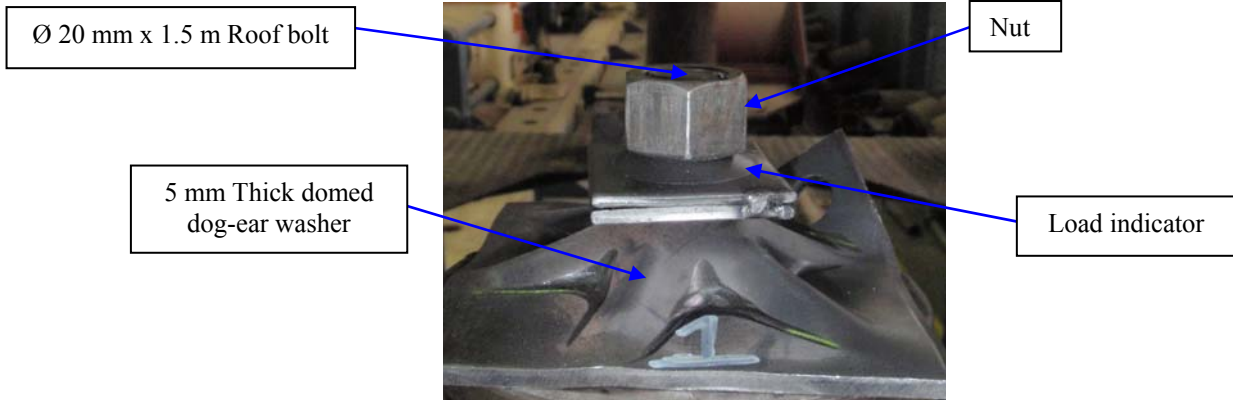
Figure 4. Y20 x 1.5 m Long Roof bolt assembly installed in the testing machine.

The nut was screwed onto the threaded end of the bar for each specimen. The load indicator together with the domed dog-ear washer were fitted adjacent to the nut. The assemblies were in turn installed in the 1000 kN Amsler Universal testing machine using suitable fittings as shown in Figure 1. A gradually increasing tensile load was applied to each assembly until failure occurred.

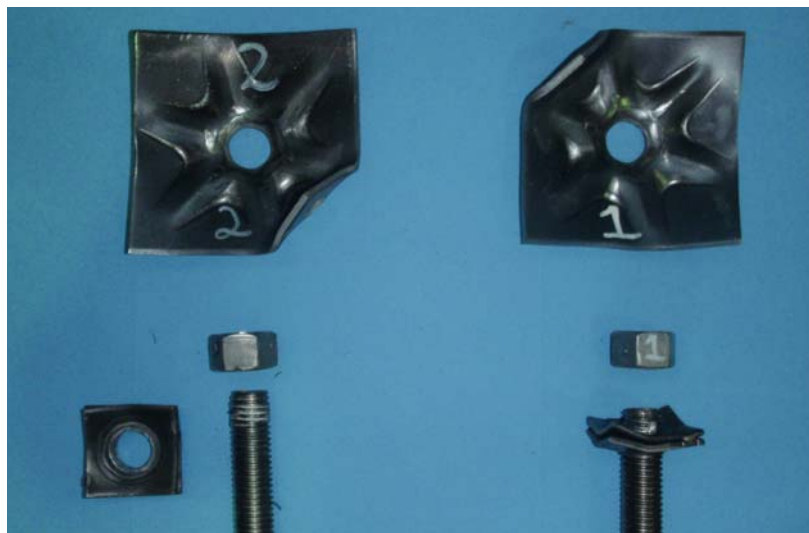
Figure 2. Y20 x 1.5 m Long Roof bolt assemblies after the test.

1. The load indicator failed (flattened).
2. The domed dog-ear washer failed (flattened).
3. The nut stripped off the roof bolt threaded portion as shown in Figure 2.

<u>Assembly No.</u>	Maximum load carried by the domed dog-ear washer (kN)	Maximum load carried by the nut (kN)
1	159.4	232.6
2	161.0	253.2
Average	160.2	242.9

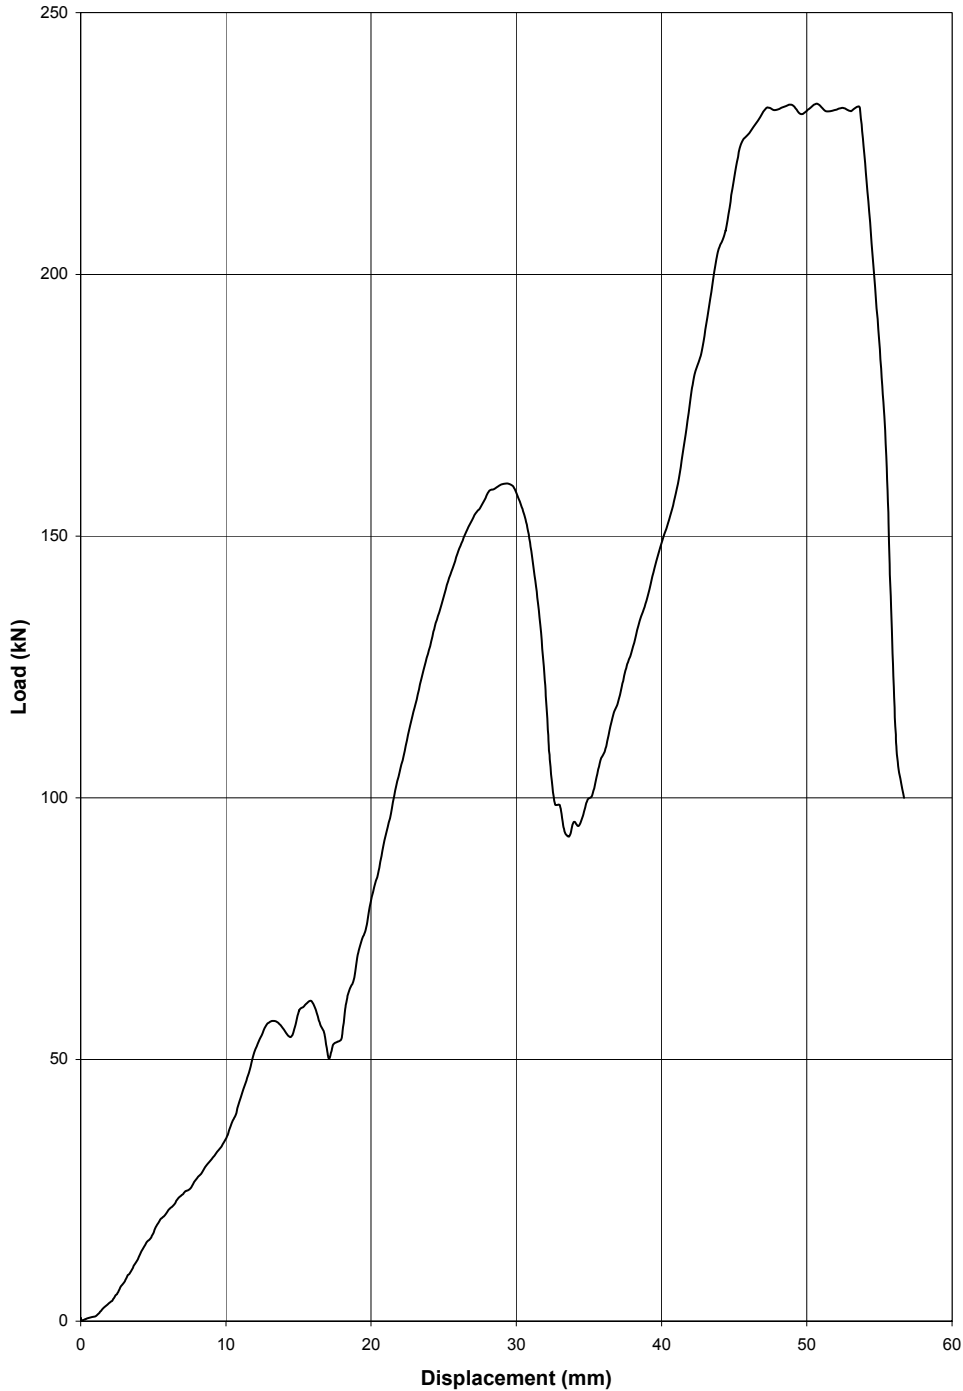
Certificate No.: T15315
Date of test: 05 May 2010
Applicant: Reunko Steel Suppliers
Description: Y20 mm x 1.5 m long roof bolt complete with nut, load indicator and 5 mm thick domed dog-ear washer (Cast No.: 093762)
Assembly No.: 1
Maximum Force: 159.4 kN (Domed dog-ear washer)
253.2 kN (Roof bolt)

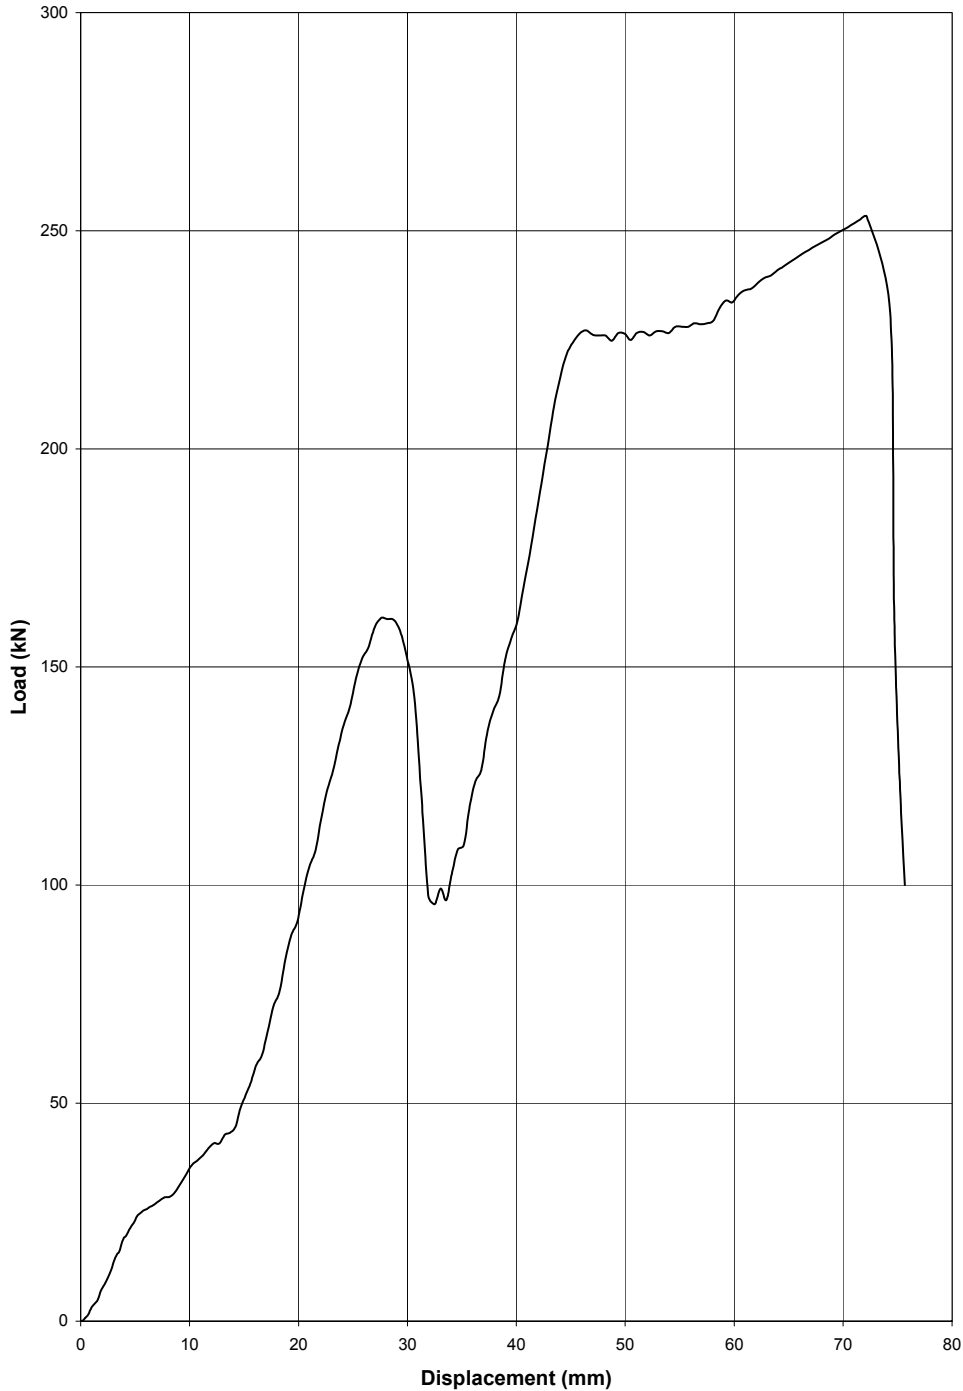
Certificate No.: T15315
Date of test: 05 May 2010
Applicant: Reunko Steel Suppliers
Description: Y20 mm x 1.5 m long roof bolt complete with nut, load indicator and 5 mm thick domed dog-ear washer (Cast No.: 093762)
Assembly No.: 2
Maximum Force: 161.0 kN (Domed dog-ear washer)
179.1 kN (Roof bolt)

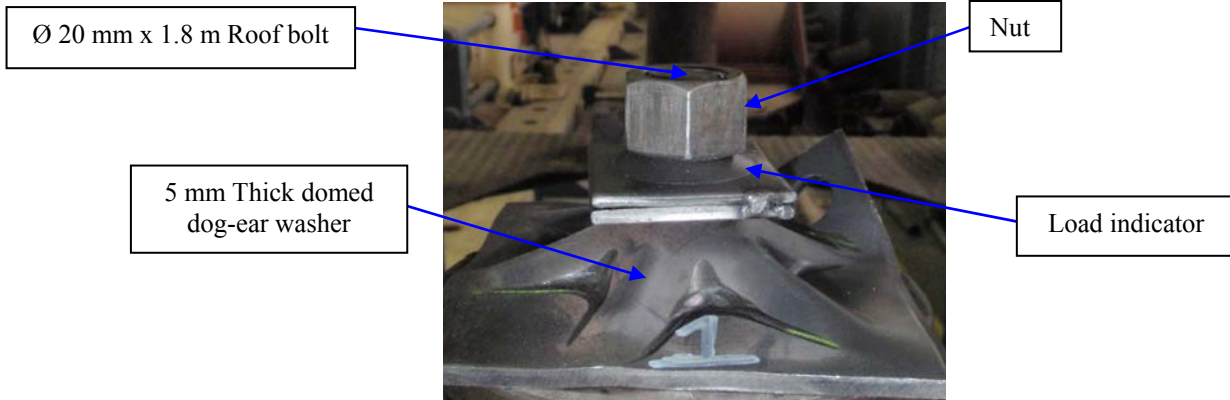
Figure 5. Y20 x 1.8 m Long Roof bolt assembly installed in the testing machine.

The nut was screwed onto the threaded end of the bar for each specimen. The load indicator together with the domed dog-ear washer were fitted adjacent to the nut. The assemblies were in turn installed in the 1000 kN Amsler Universal testing machine using suitable fittings as shown in Figure 1. A gradually increasing tensile load was applied to each assembly until failure occurred.

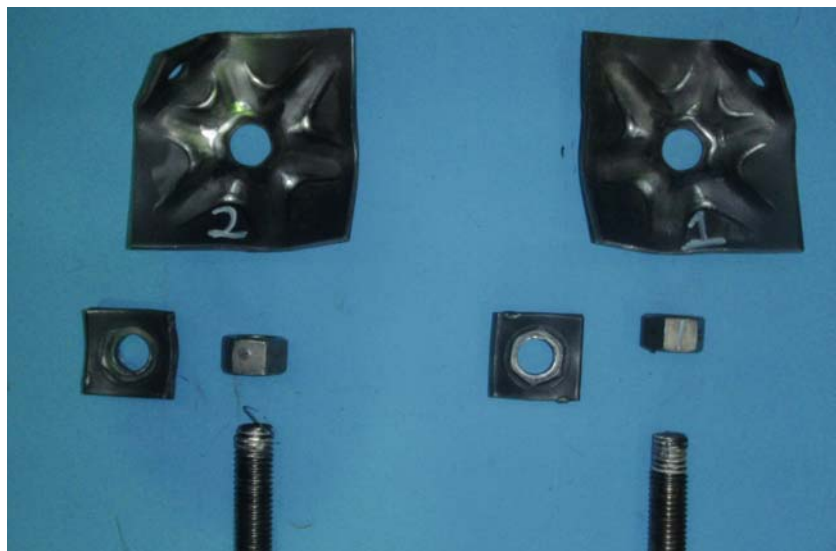
Figure 2. Y20 x 1.8 m Long Roof bolt assemblies after the test.

1. The load indicator failed (flattened).
2. The domed dog-ear washer failed (flattened).
3. The nut stripped off the roof bolt threaded portion as shown in Figure 2.

<u>Assembly No.</u>	Maximum load carried by the domed dog-ear washer (kN)	Maximum load carried by the nut (kN)
1	163.8	253.8
2	158.8	270.2
Average	161.3	262.0

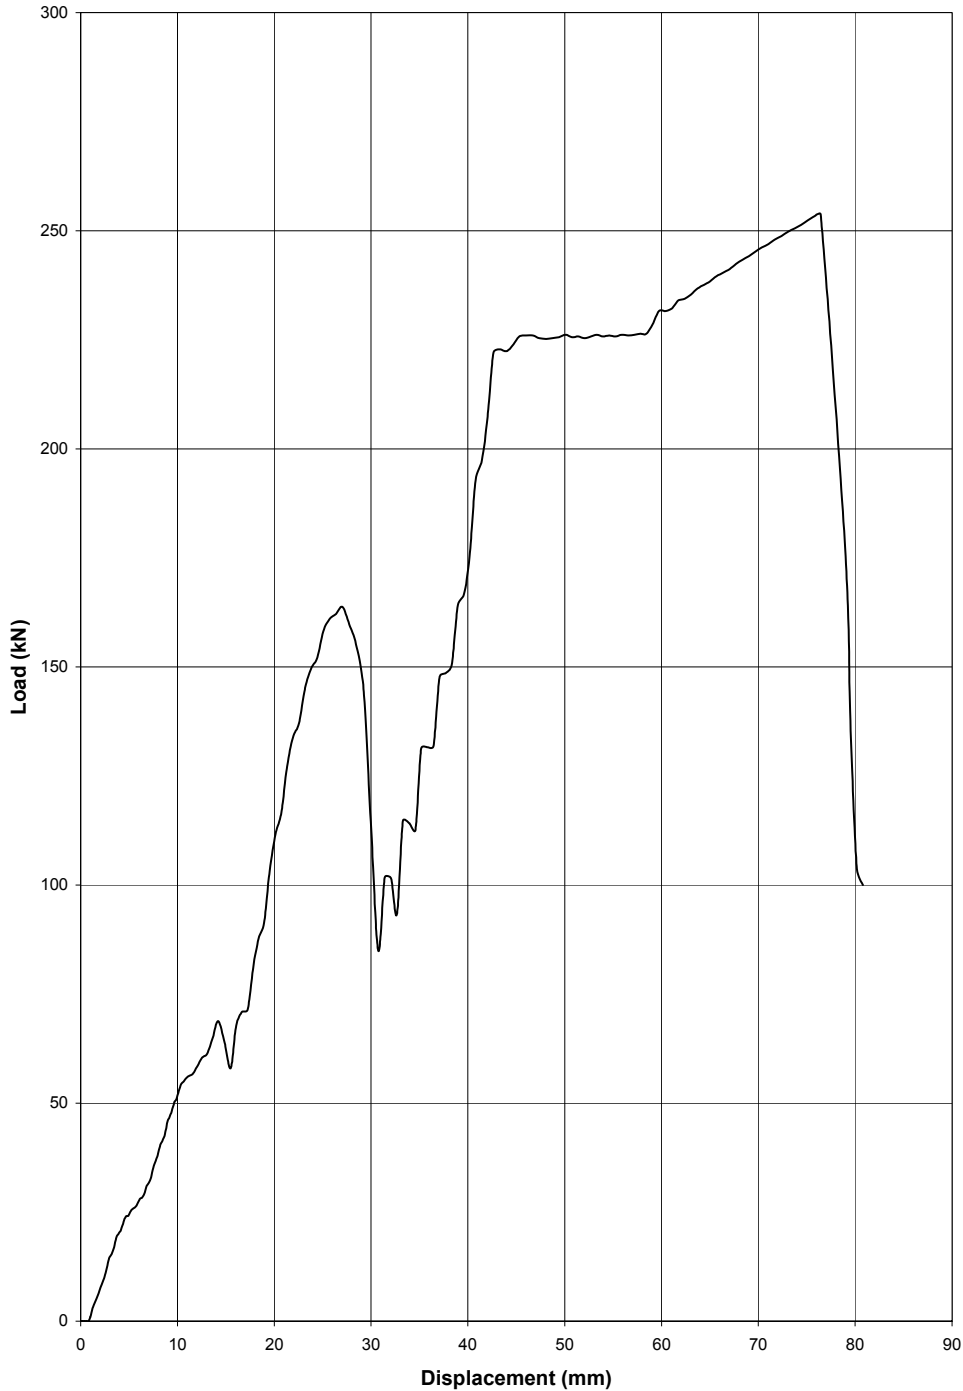
Certificate No.: T15315
Date of test: 05 May 2010
Applicant: Reunko Steel Suppliers
Description: Y20 mm x 1.5 m long roof bolt complete with nut, load indicator and 5 mm thick domed dog-ear washer (Cast No.: 093762)
Assembly No.: 1
Maximum Force: 163.8 kN (Domed dog-ear washer)
253.80 kN (Roof bolt)

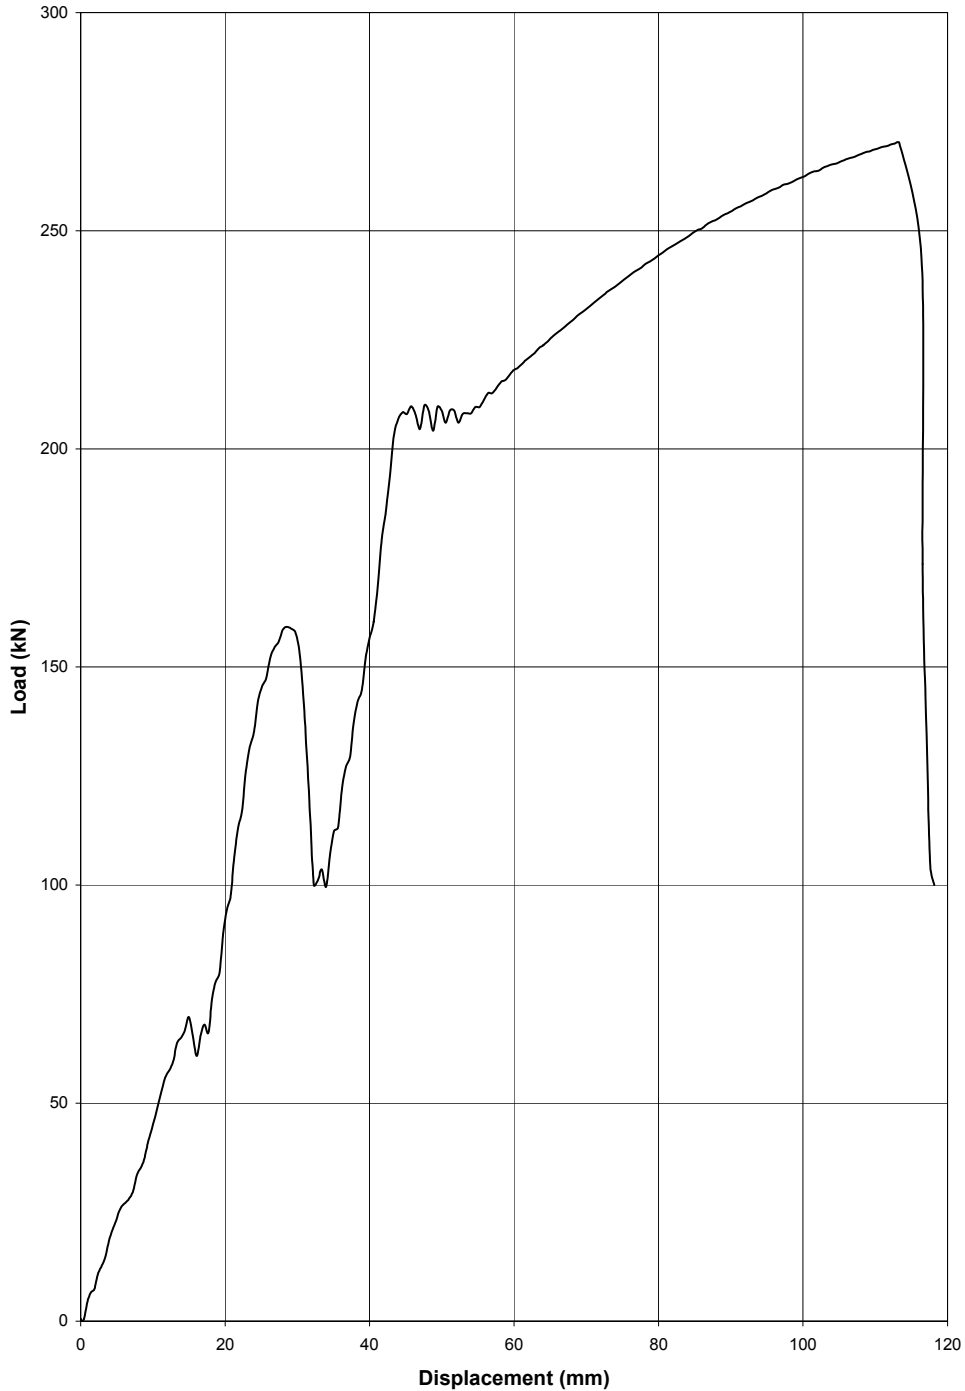
Certificate No.: T15315
Date of test: 05 May 2010
Applicant: Reunko Steel Suppliers
Description: Y20 mm x 1.5 m long roof bolt complete with nut, load indicator and 5 mm thick domed dog-ear washer (Cast No.: 093762)
Assembly No.: 2
Maximum Force: 158.8 kN (Domed dog-ear washer)
270.2 kN (Roof bolt)
